Re: MS4 Inspection - Village of Port Jefferson
NPDES Permit No. NYR20A326

MS4 Inspection Report/Village of Port Jefferson, NY (NYR20A326)
August 21-22, 2013

PHOTOGRAPH LOG (Panasonic Lumix L8Z)

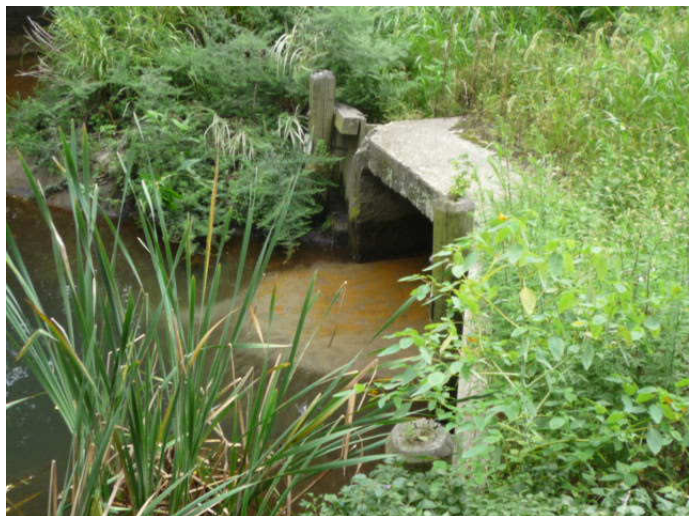
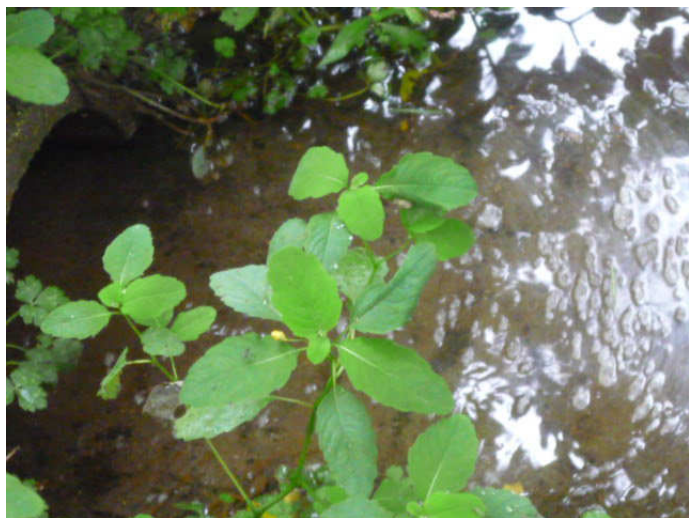
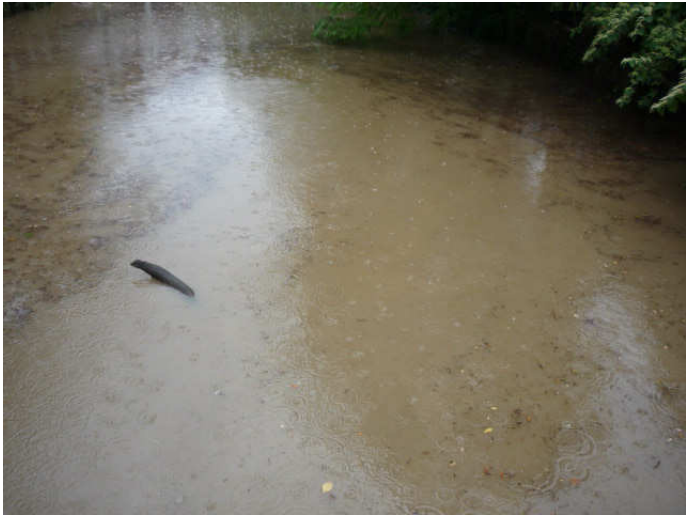
Three outfalls pictured above draining to Mill Creek exhibiting high loads of silt, sediment, and floatables

1. rust and iron bacteria in pipe
2. there was a small silt/sediment pile in front of outfall, possible sampling point, could not get GPS
3. fragmities
4. drop grate down to creek from bridge
5. could not observe
6. could not observe
7. photo, #31, #13 & #33 all in the same location
8. possible sample point, 40 56.699, -073 04.285
9. roof drain

The following outfalls have been recommended for EPA sampling due to indications of silt, sediment, plumes, or oily sheens in and around the discharge locations.
